Wet Detention Basin Operation and Maintenance Agreement

Project name: Summer Grove Phase II

BMP drainage area number: 1

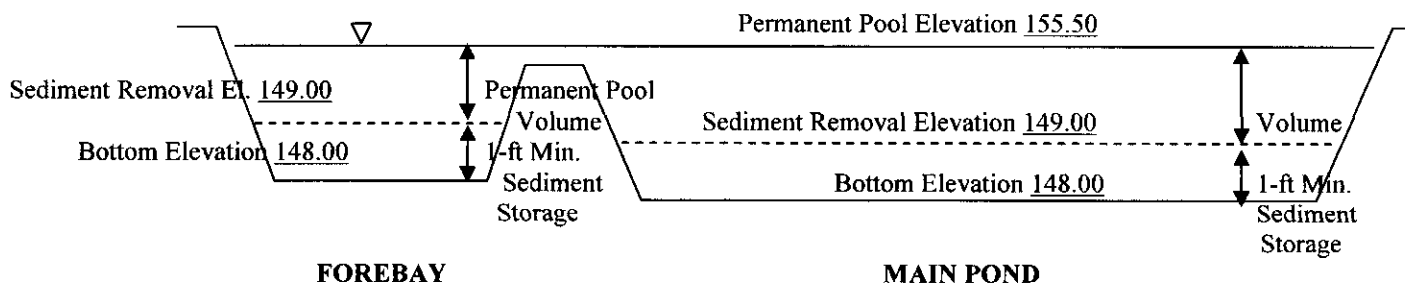
BASIN DIAGRAM
(fill in the blanks)

When the permanent pool depth reads 6.50 feet in the main pond, the sediment shall be removed.

When the permanent pool depth reads 6.50 feet in the forebay, the sediment shall be removed.

The measuring device used to determine the sediment elevation shall be such that it will give an accurate depth reading and not readily penetrate into accumulated sediments.
